HOUSATONIC RIVER FLOOD CONTROL

NORTHFIELD BROOK DAM & RESERVOIR

DESIGN MEMORANDUM NO. 2

SITE GEOLOGY

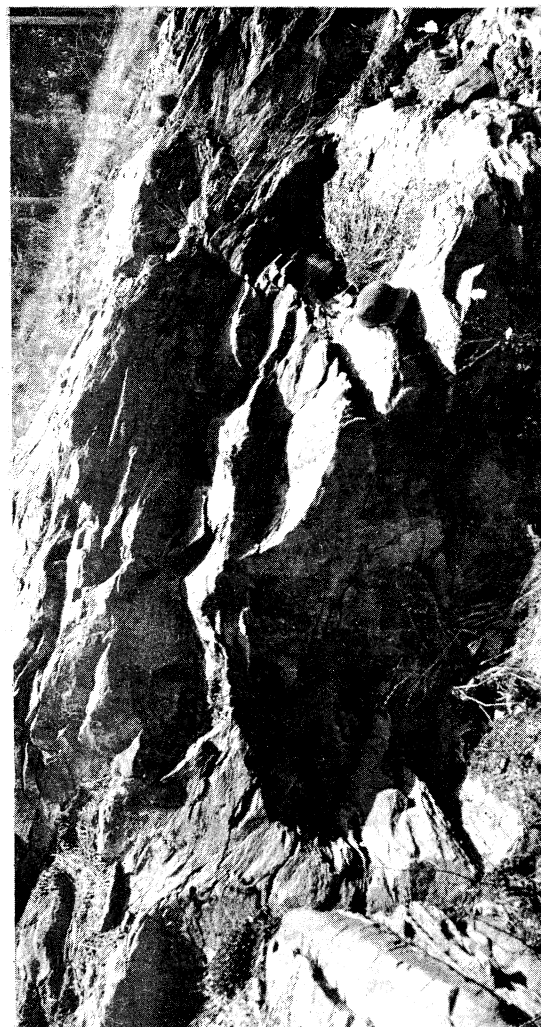
TYPICAL BEDROCK EXPOSED IN HIGHWAY CUT APPROXIMATELY
600 FEET DOWNSTREAM FROM CENTERLINE OF DAM

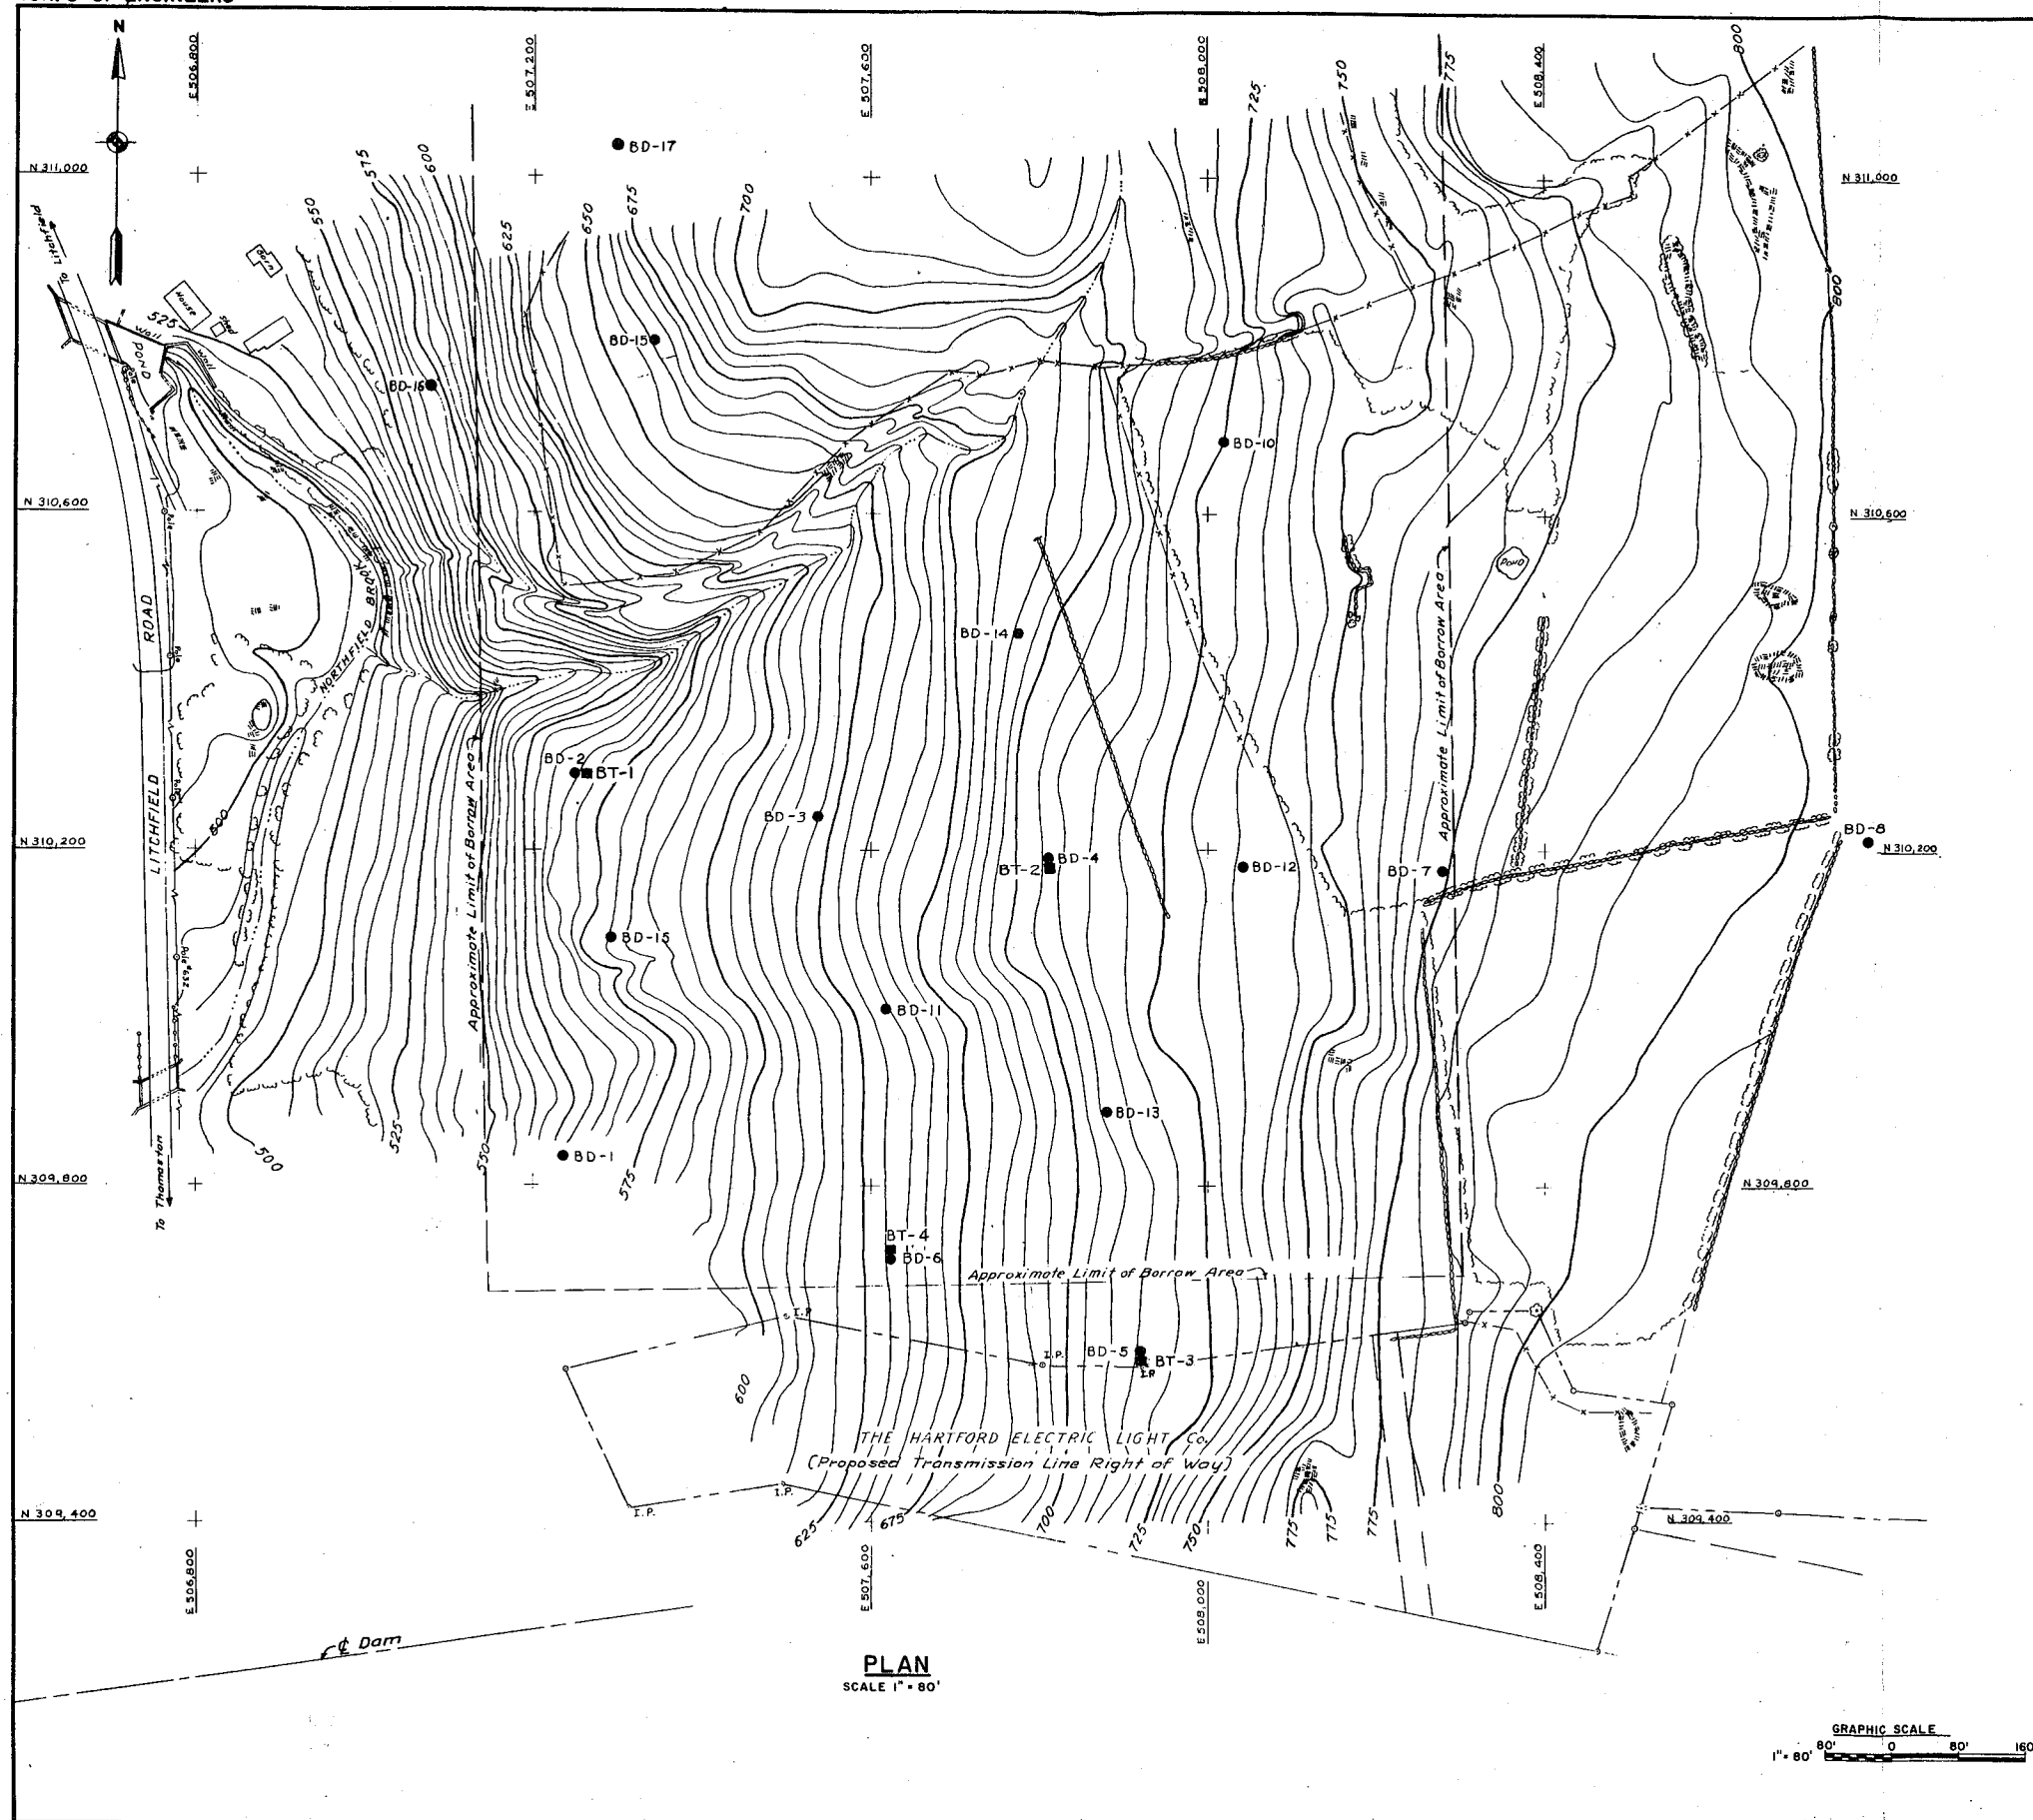
U.S. ARMY ENGINEER DIVISION, NEW ENGLAND CORPS OF ENGINEERS WALTHAM, MASS.			
DES. BY H.A.V.		CK. BY H.C.S.	R.C.G.
SUBMITTED H.C. HANLEY HEAD, GEOLOGY SECTION PROJECT ENGINEER			
APPROVAL RECOMMENDED DATE CHIEF, P & M'S BRANCH		APPROVED DATE CHIEF, ENGINEERING DIVISION	
APPROVAL RECOMMENDED DATE CHIEF, P & M'S BRANCH		APPROVED DATE CHIEF, ENGINEERING DIVISION	
NORTHFIELD BROOK, CONNECTICUT PLAN OF BORROW EXPLORATIONS APRIL 1982			
SCALE AS SHOWN SPEC. NO. CIV. ENG.-19-016- DRAWING NUMBER			
SHEET

18. Impervious and Random Material. - Impervious material will be borrowed from the area located immediately upstream and above the left abutment of the dam. The overburden in the area is glacial till which, although characteristically variable, consists mainly of compact, relatively impervious, gravelly, silty and clayey sand with scattered cobbles and boulders. Borings indicate that the material ranges in thickness from 9 feet to more than 75 feet but throughout most of the area the till appears to be from 20 to 35 feet in thickness. The locations of all explorations are shown on Plan of Borrow Explorations, Plate 2-8, and description and classification of materials encountered are shown in Records of Borrow Explorations, Plates 2-9 and 2-10. Material from required excavations at the site, consisting mainly of random type materials, will be utilized in appropriate sections of the embankment.
